The Rise of Dam Removal in New England

Noah Snyder (noah.snyder@bc.edu)
Boston College
Earth and Environmental Sciences

- Primer on dams and sedimentation in reservoirs
- History of dam removal in New England; local examples; dam removal as a stream restoration activity
- What we have learned from 10 years of studying the removal of the Merrimack Village Dam on the Souhegan River, NH?

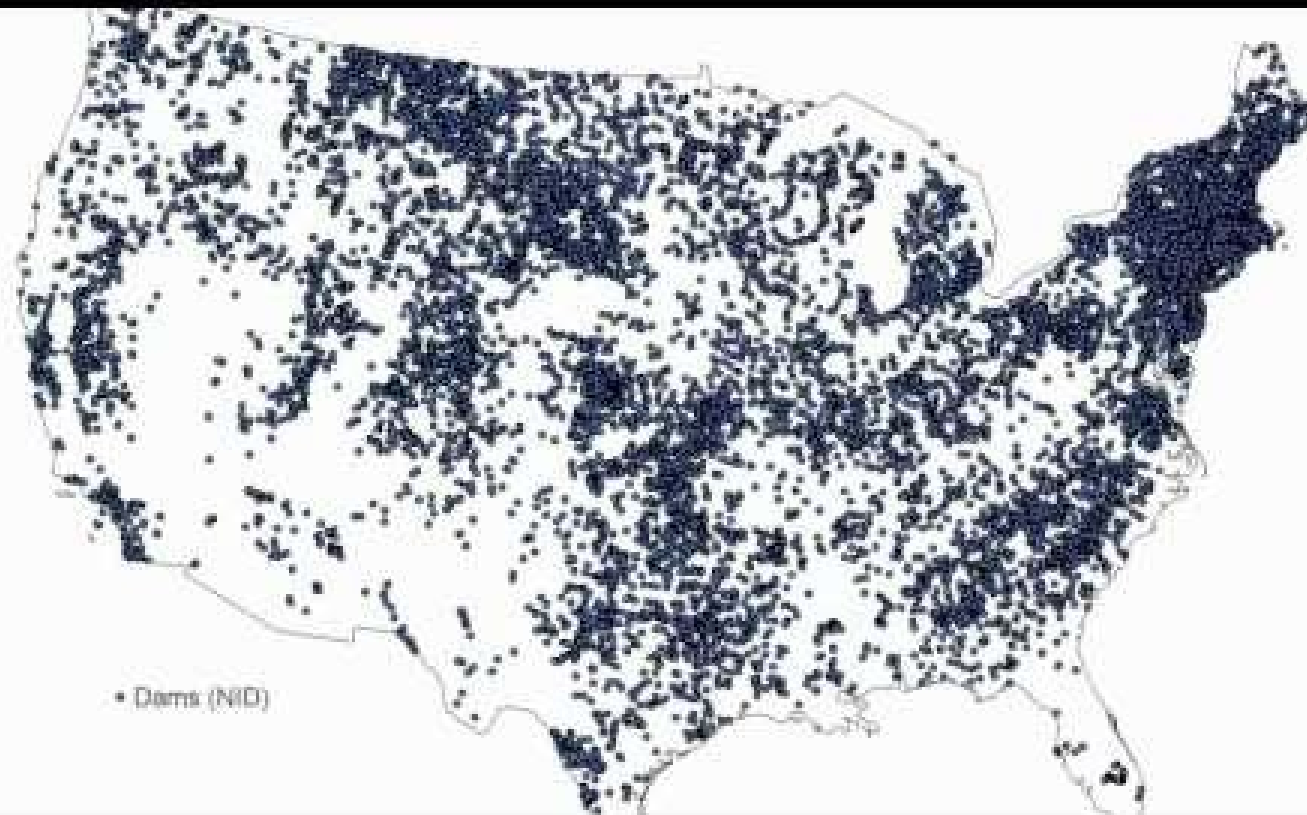
Dam construction in the U.S., 1800-2003 (Syvitski, 2011)

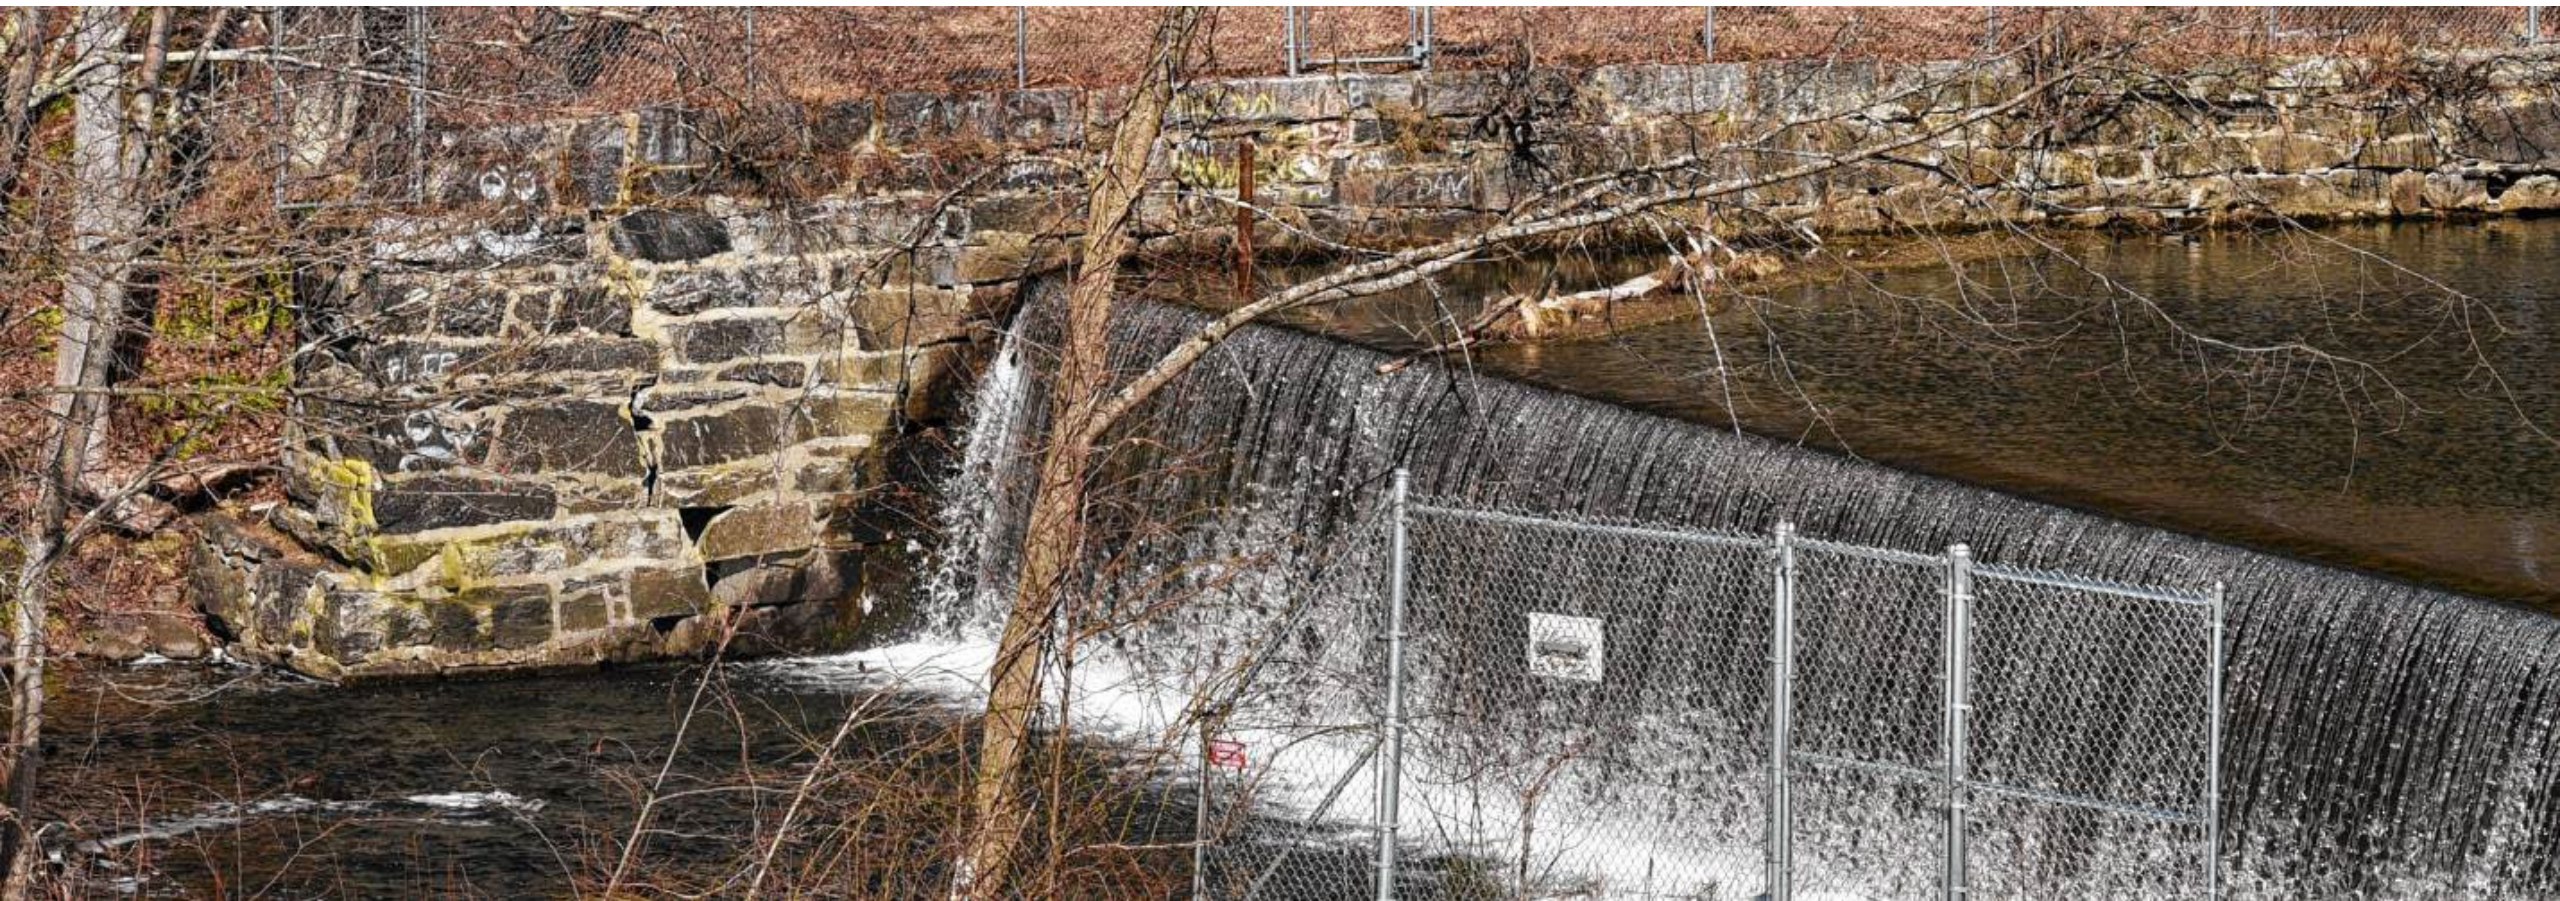
Run-of-the-river dam:
Upper Bondsville Dam, Swift River, MA

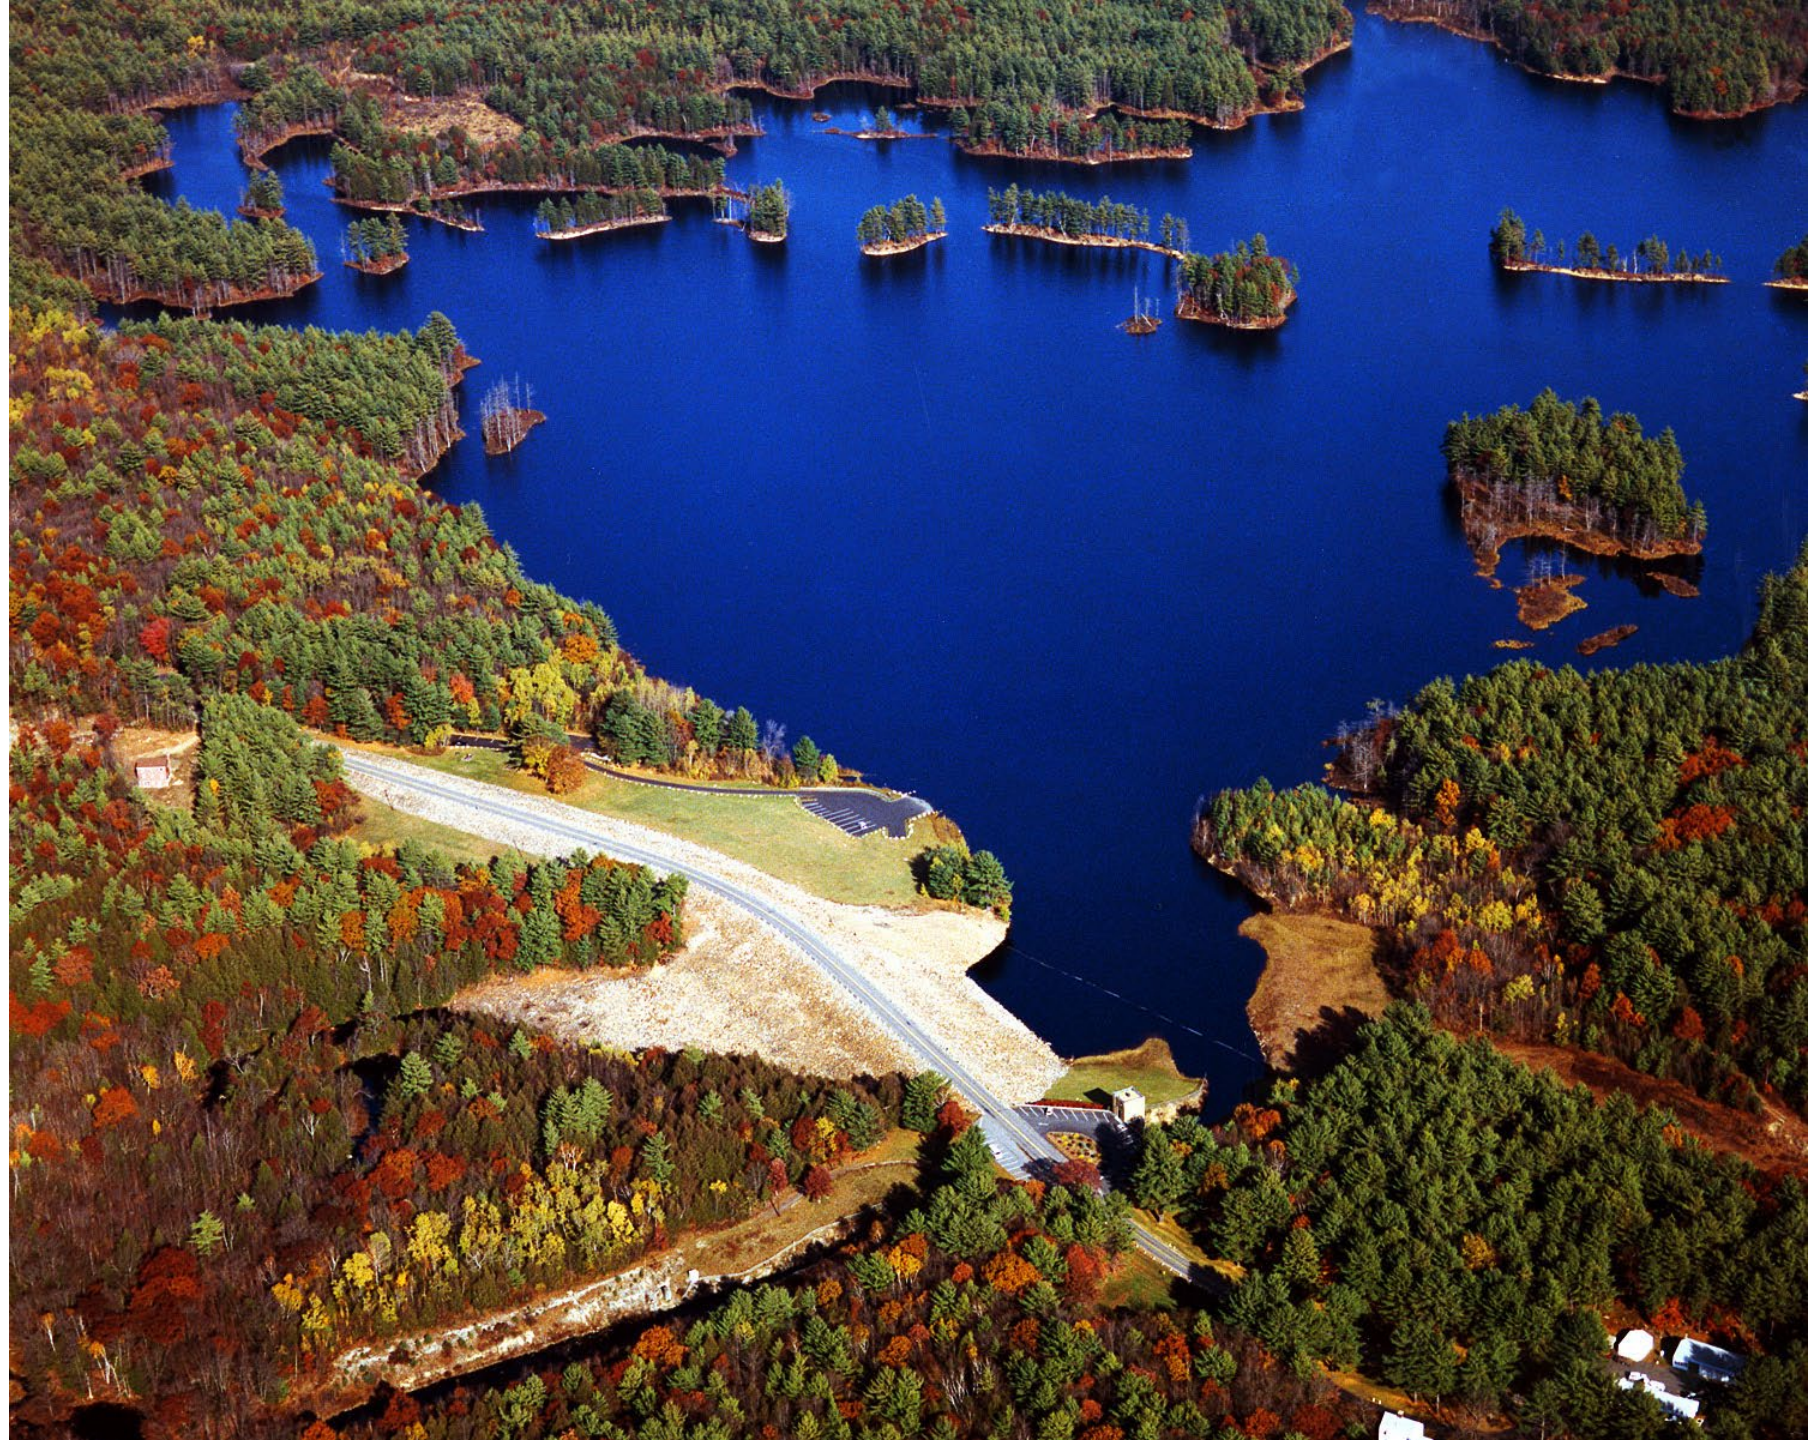
Flood control dam:
Tully Lake, MA
(USACE)

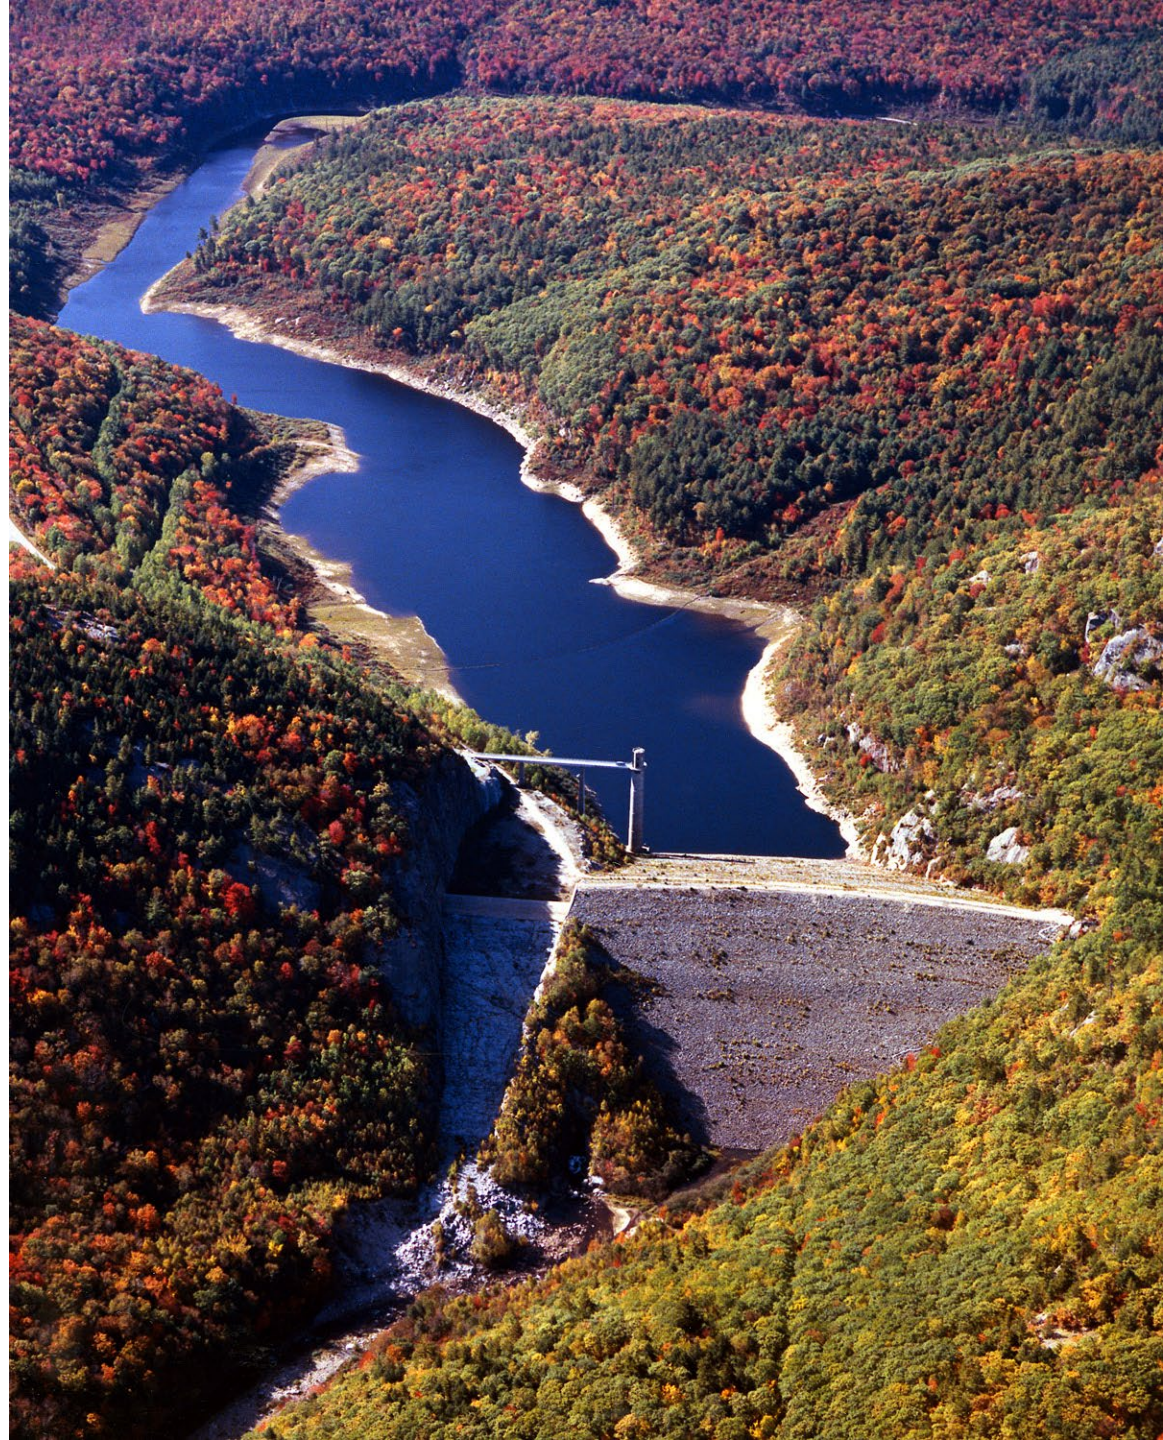
Flood control dam:
Ball Mountain Lake,
West River, VT
(USACE, 1999)

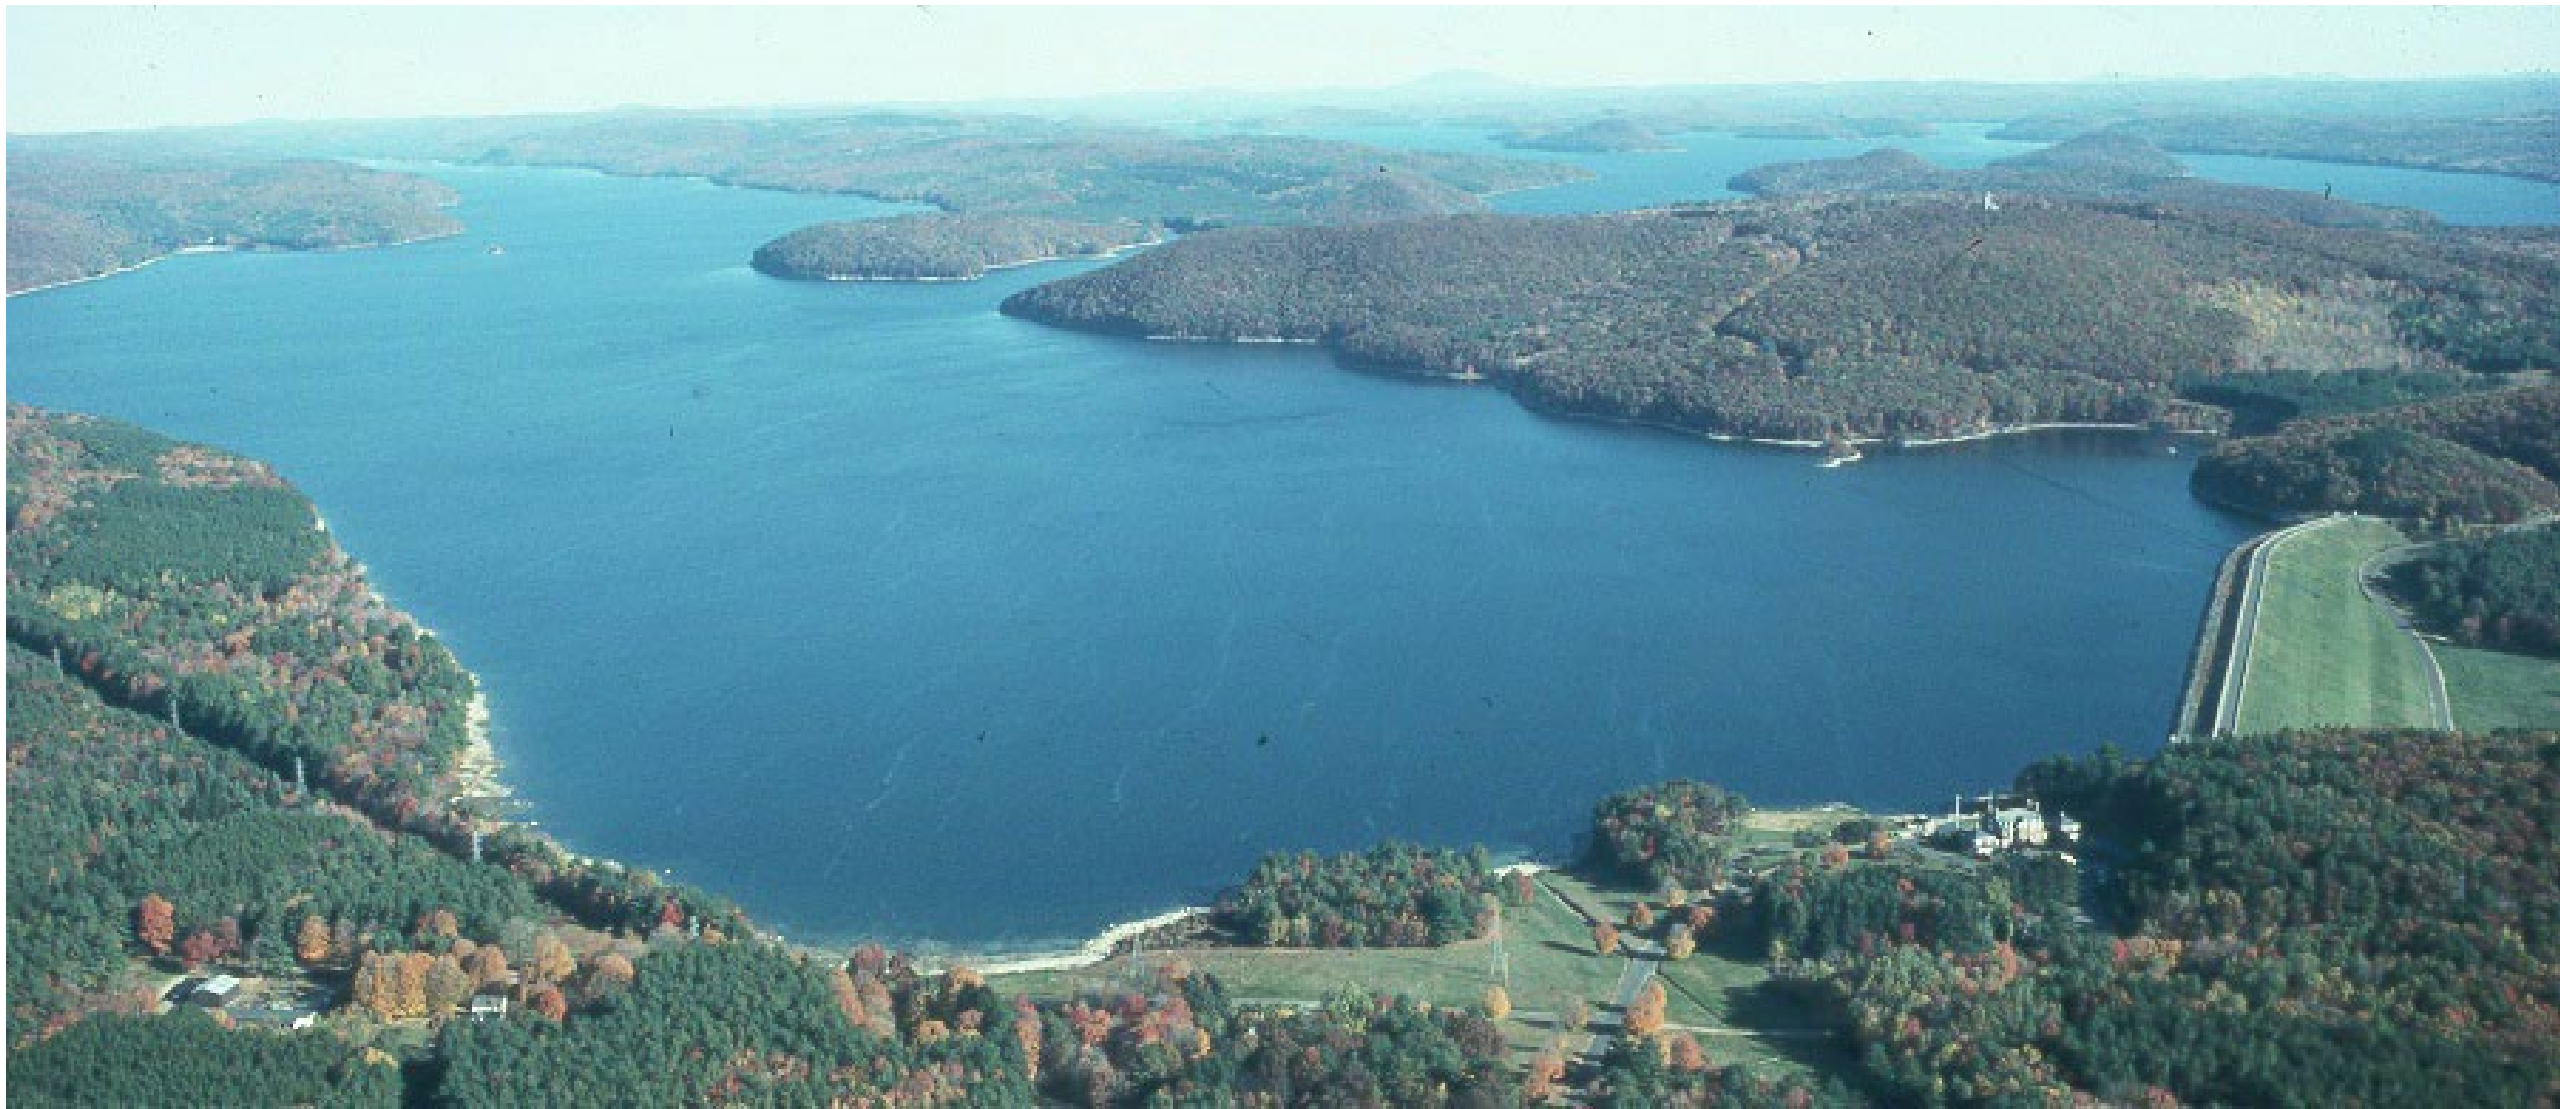
Quabbin Reservoir and Winsor Dam, Swift River, MA, 1946 (massmoments.org)
170 ft (52 m) high, 412 billion gallons of water storage (1.56 km³)

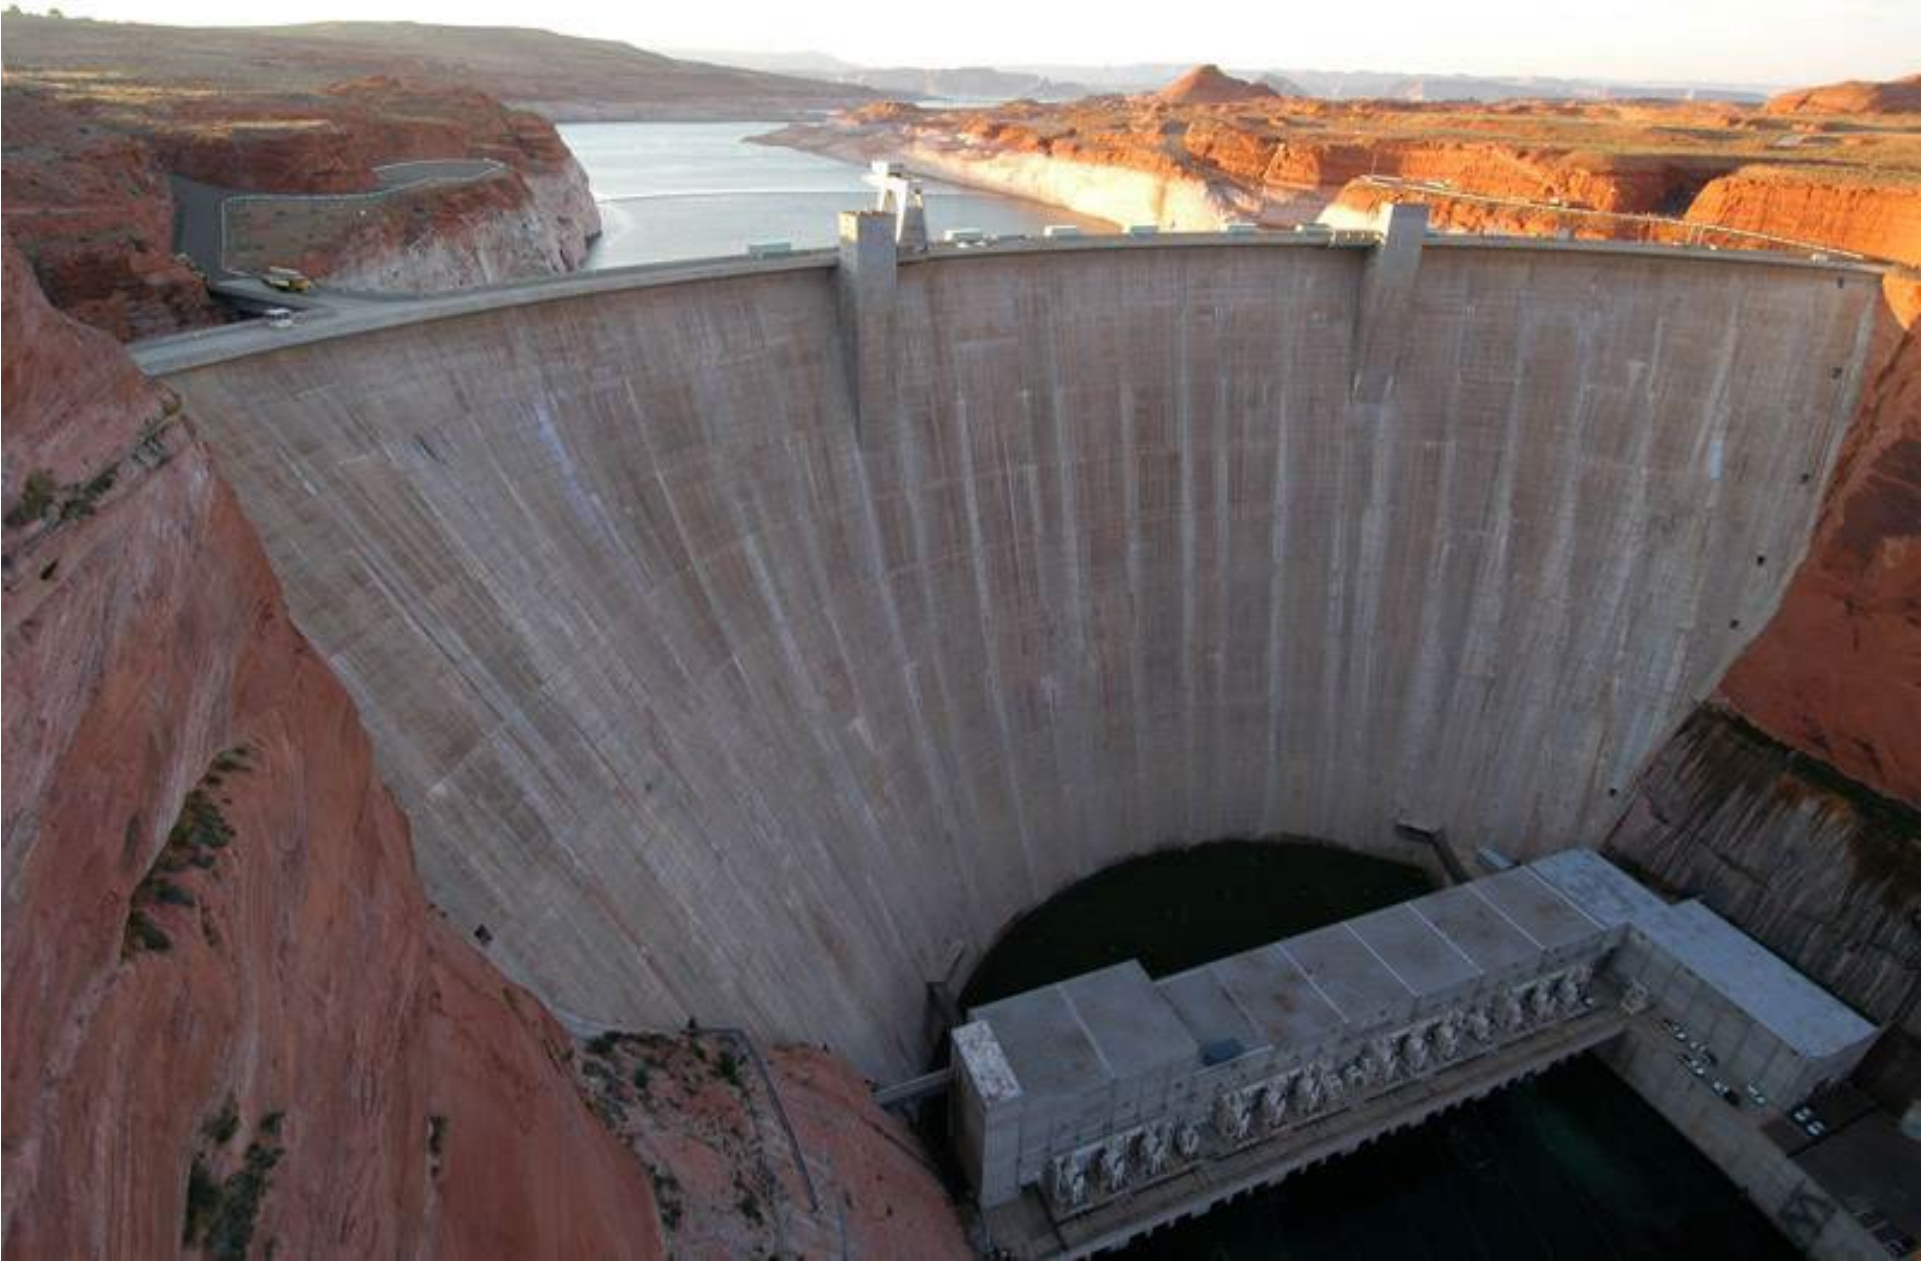
Glen Canyon Dam, Colorado River, AZ/UT
316 m tall, 32 km³ of storage, 1300 MW power generation

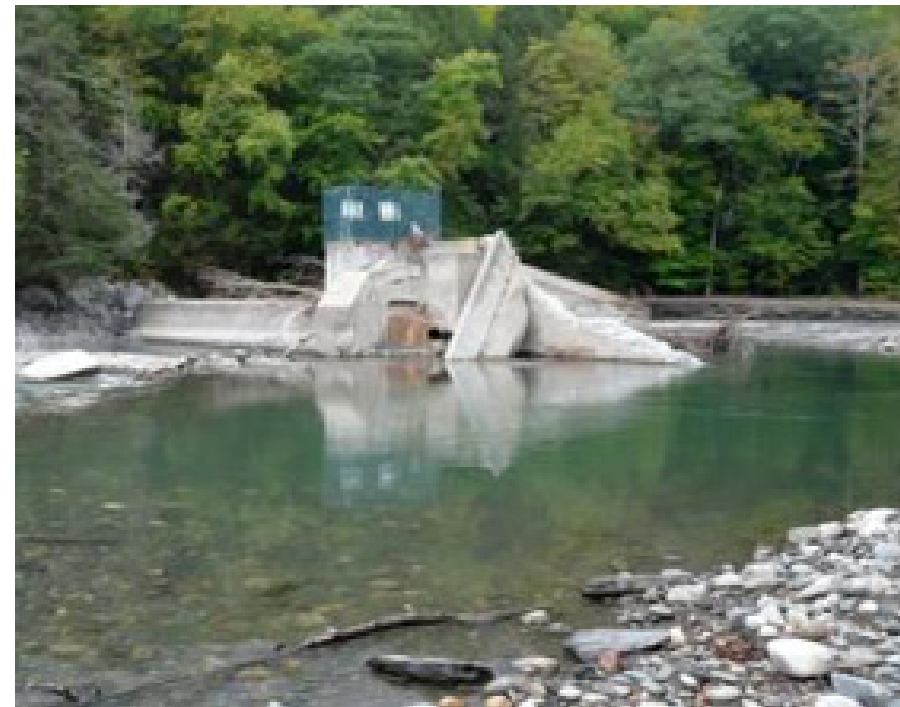
Failed dam on the Green River in Massachusetts shows the river flowing around the spillway and through the retaining wall breach.

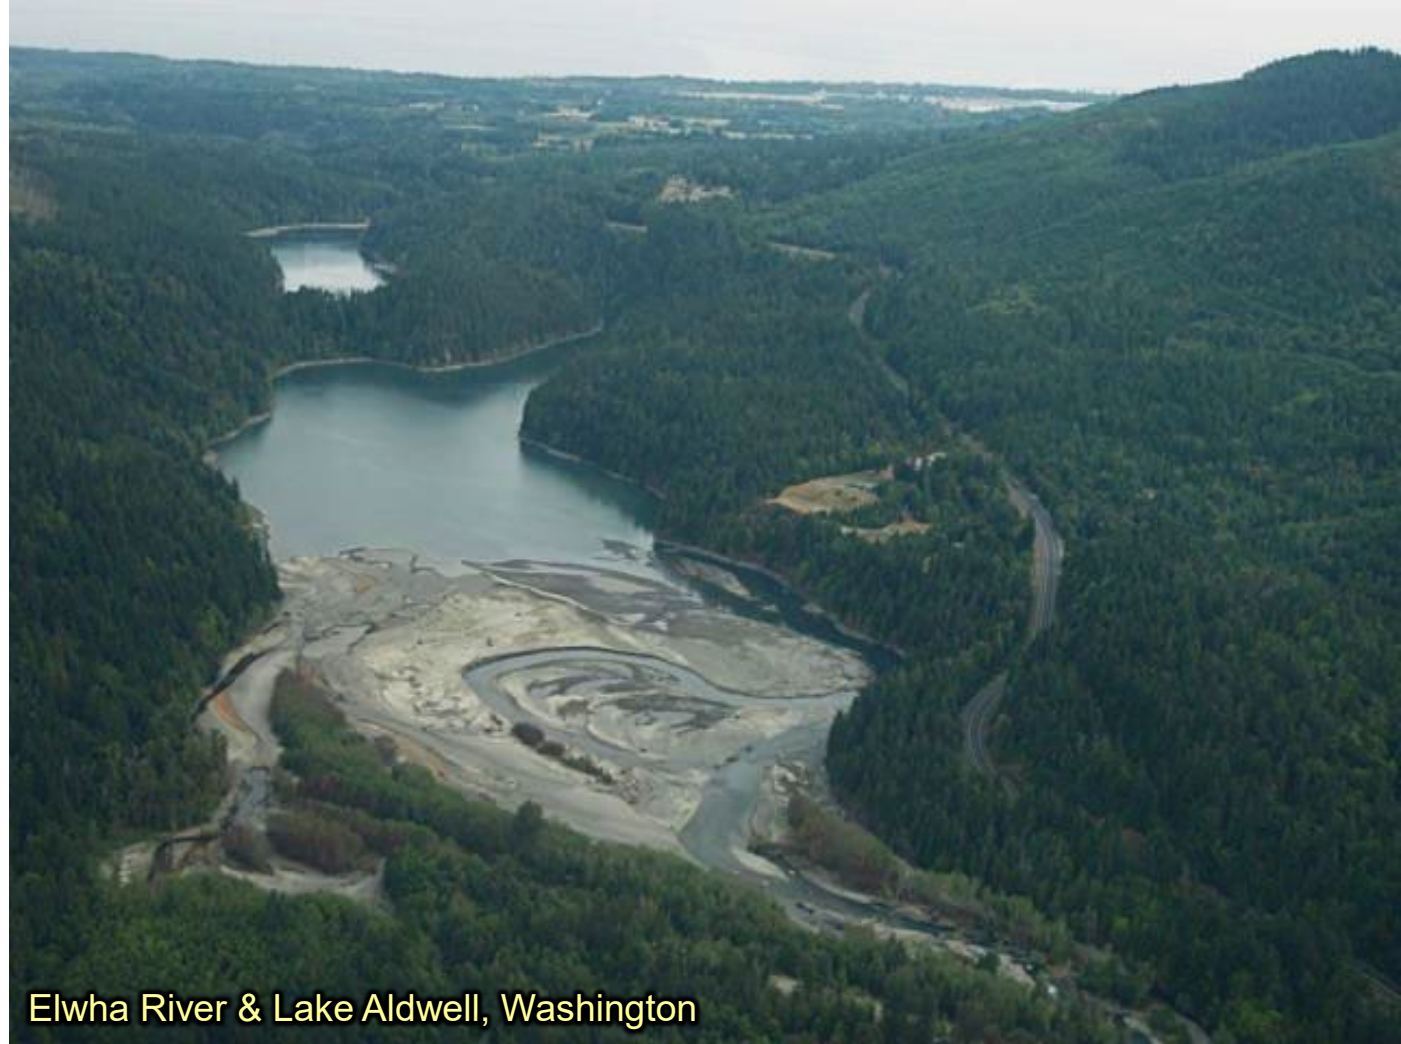
1 This stream has a typical stream profile.

2 A dam is built, impounding a reservoir behind it.

3 The stream dumps sediments in the reservoir, creating a shallower slope profile.

4 The higher-velocity water, robbed of its sediments, erodes below the dam, creating a new, steeper slope profile.

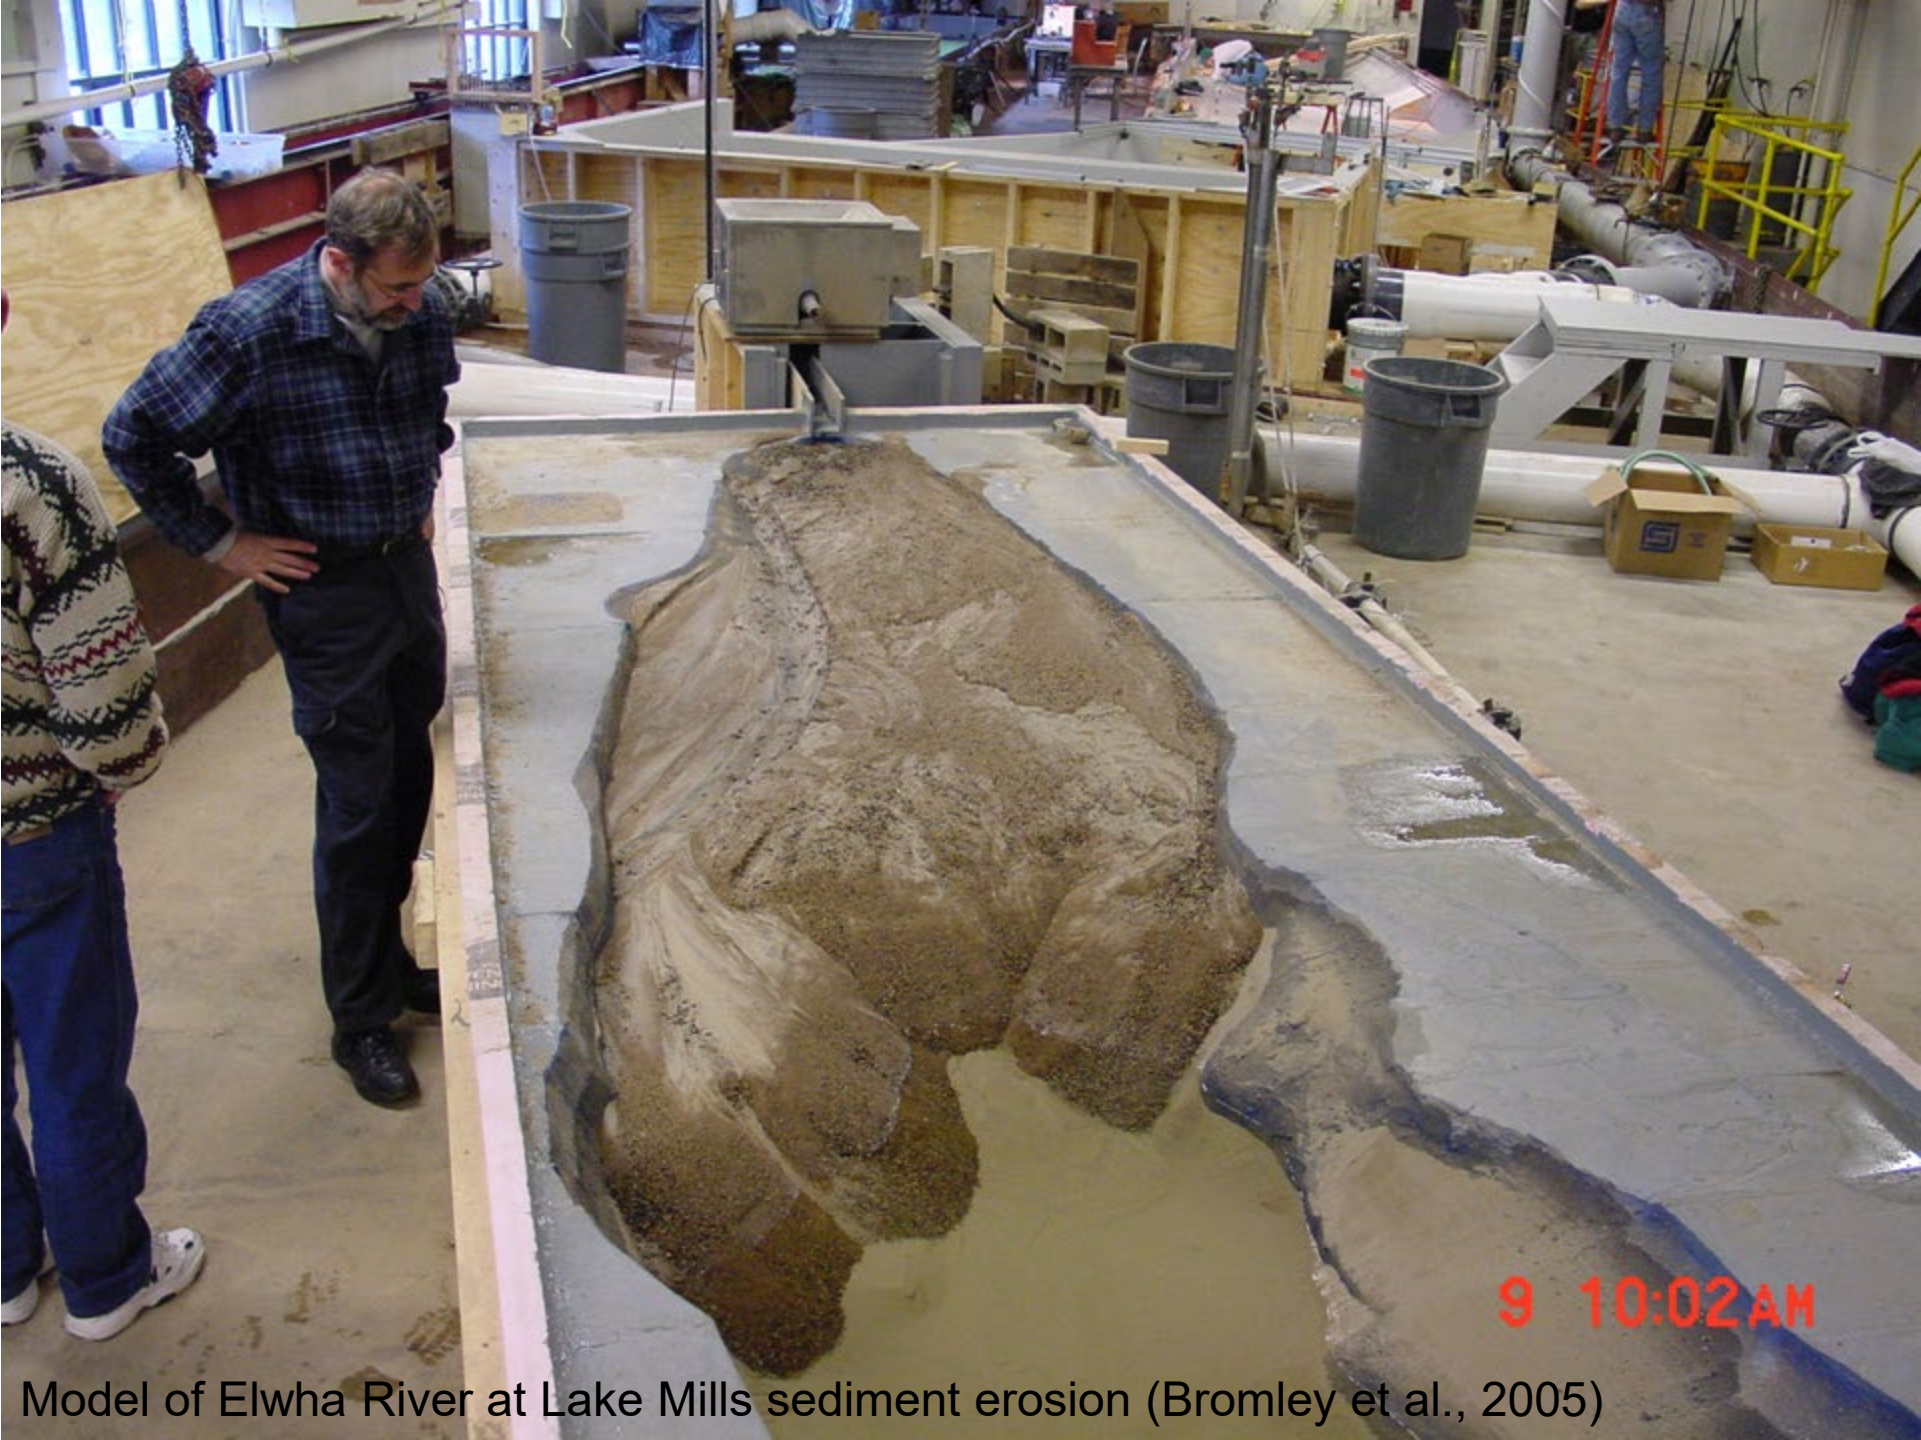
Model of Elwha River at Lake Mills sediment erosion (Bromley et al., 2005)

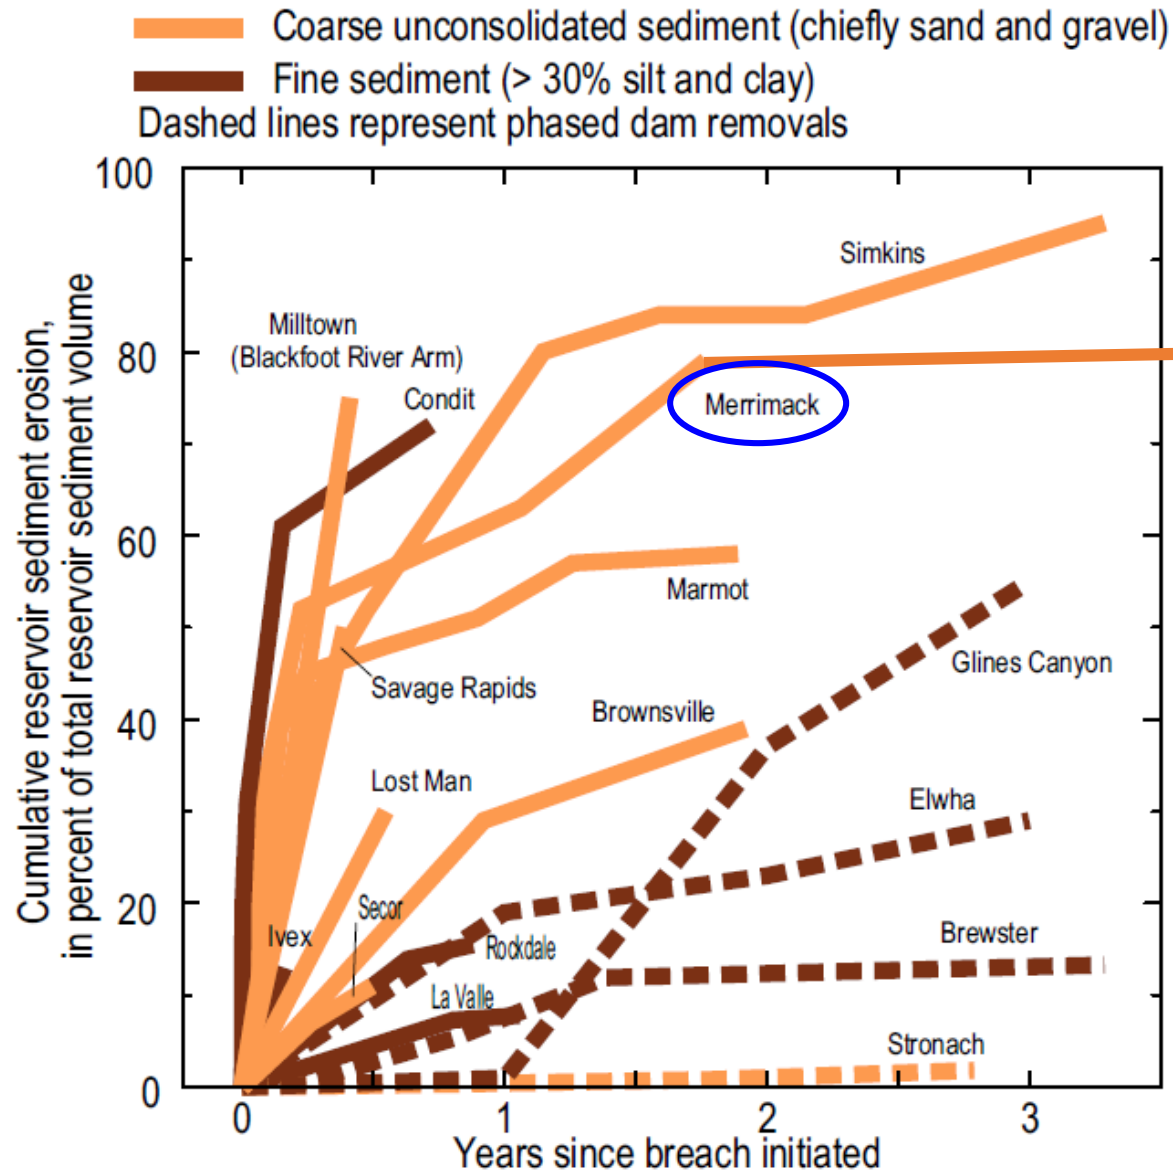
Figure 3. Percentage of reservoir sediment eroded with time after dam removal. Modified from Major et al. [2017], Sawaske and Freyberg [2012], and Grant and Lewis [2015].

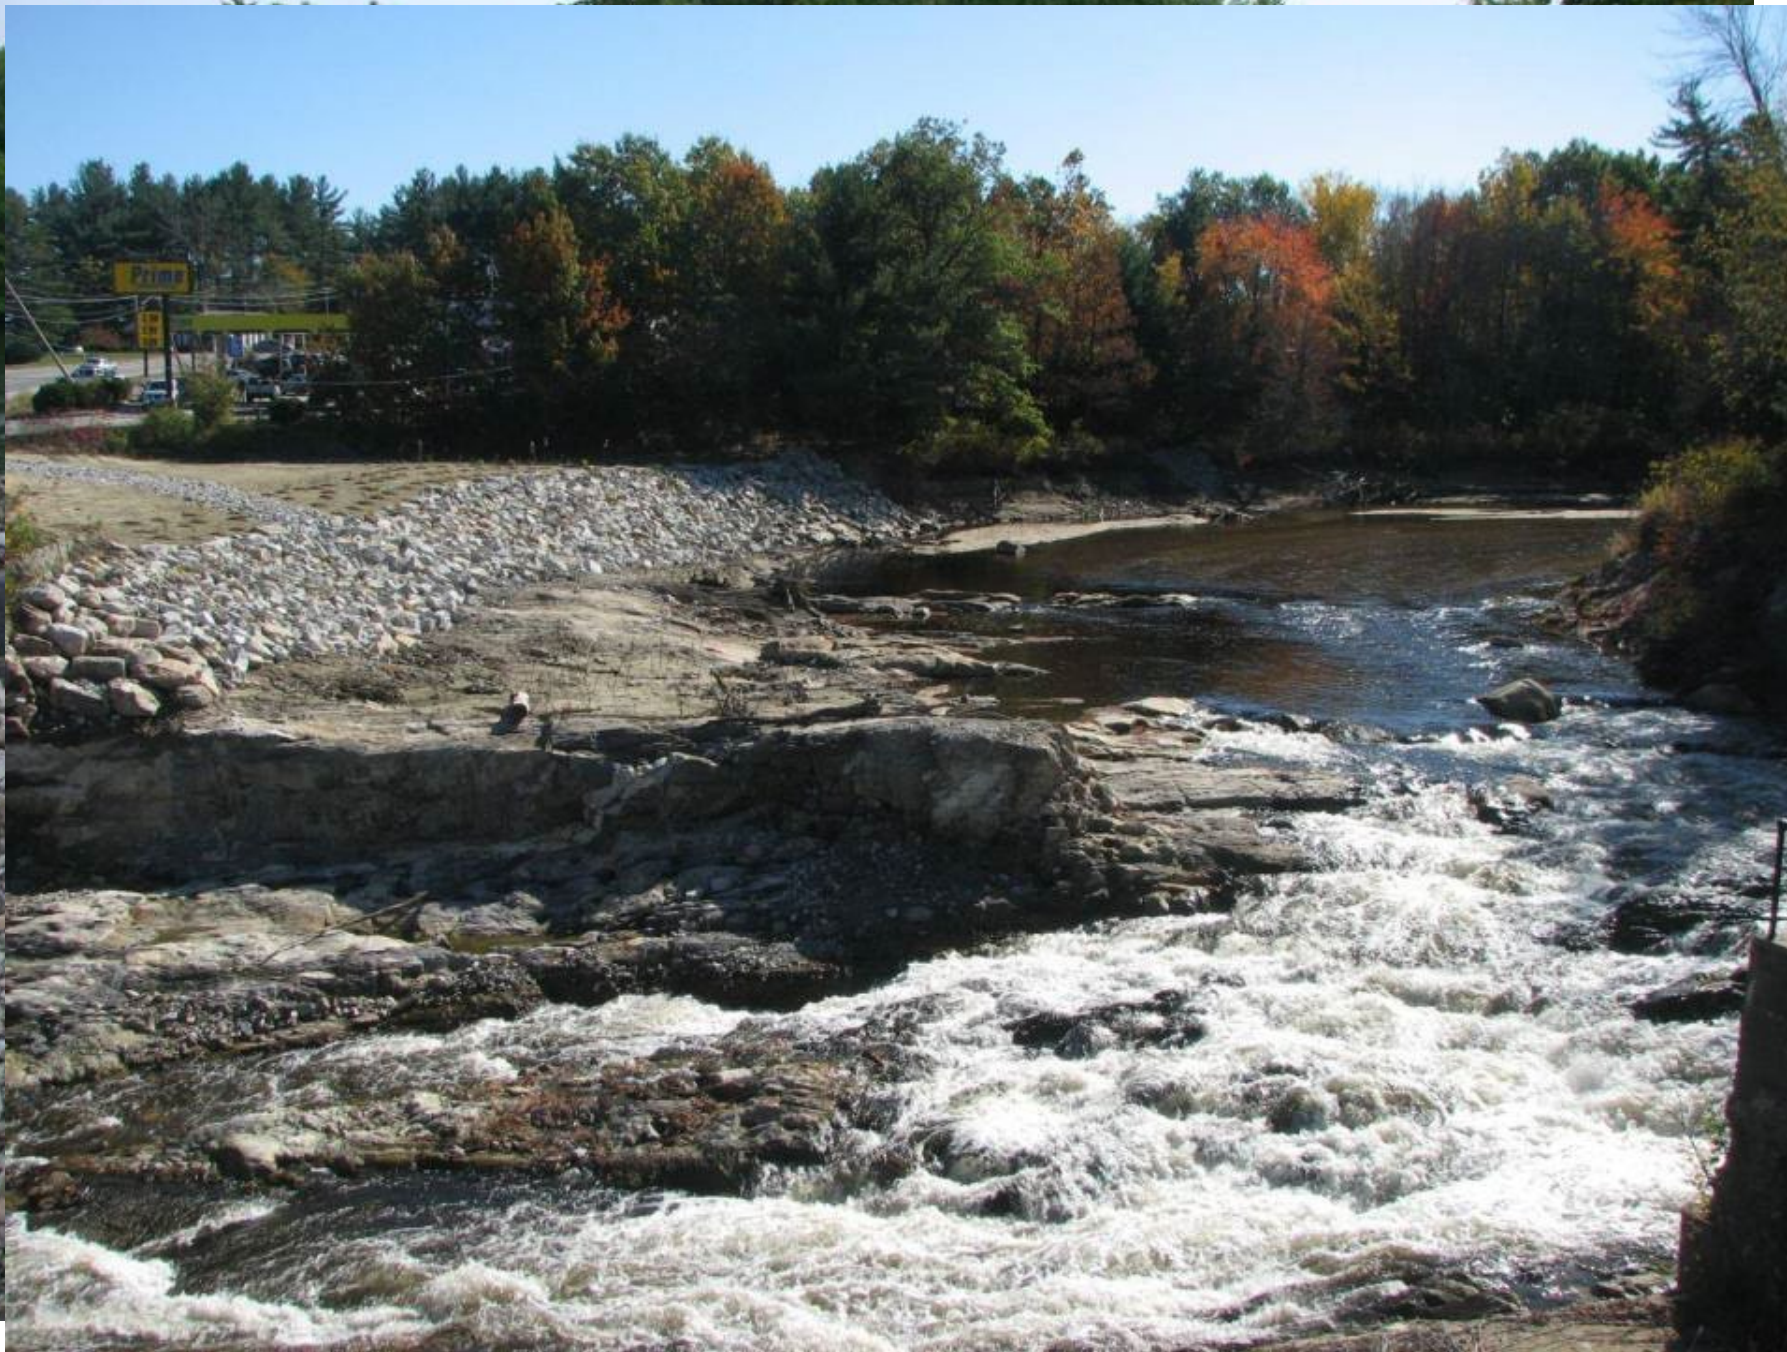
Merrimack Village Dam, Souhegan River, NH

- First dam built in ca. 1734, likely multiple breaches over the next ~2 centuries
- Modern concrete structure built on top of an existing dam in 1907, spray skirt added in 1934
- Stored ~62000 m³ of sediment (Gomez and Sullivan Engineers, 2006) in the reservoir
- Removed in August 2008, 3.9 m base-level drop
- We conducted 10 repeat surveys from 2007 to 2018
