The Rise of Dam Removal in New England

Noah Snyder (noah.snyder@bc.edu)
Boston College
Earth and Environmental Sciences

- Primer on dams and sedimentation in reservoirs
- History of dam removal in New England; local examples; dam removal as a stream restoration activity
- What we have learned from 10 years of studying the removal of the Merrimack Village Dam on the Souhegan River, NH?

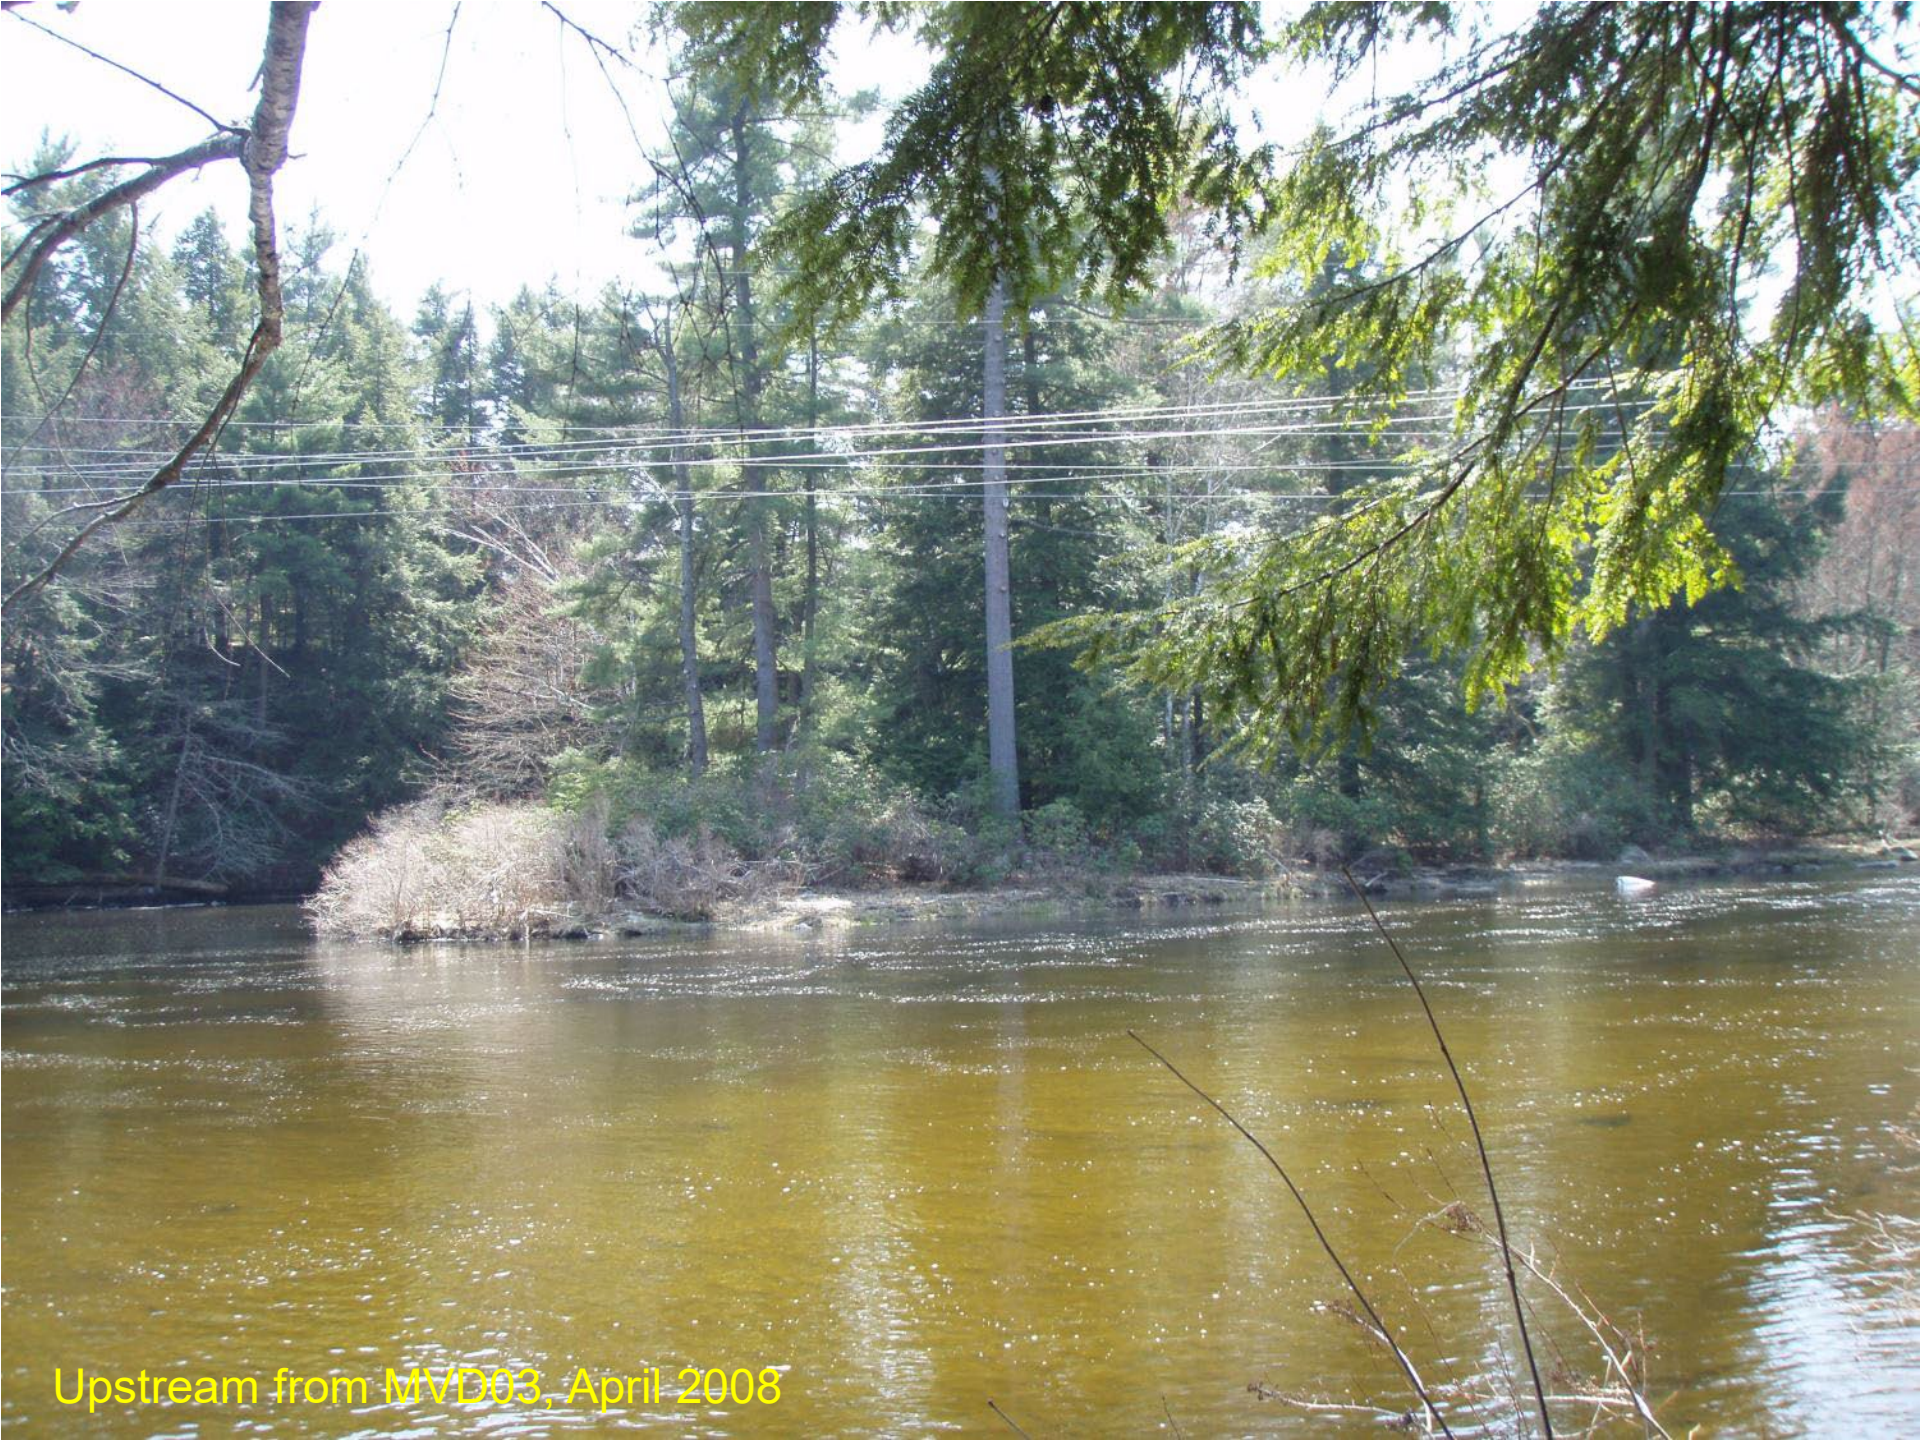
Upstream from MVD03, April 2008

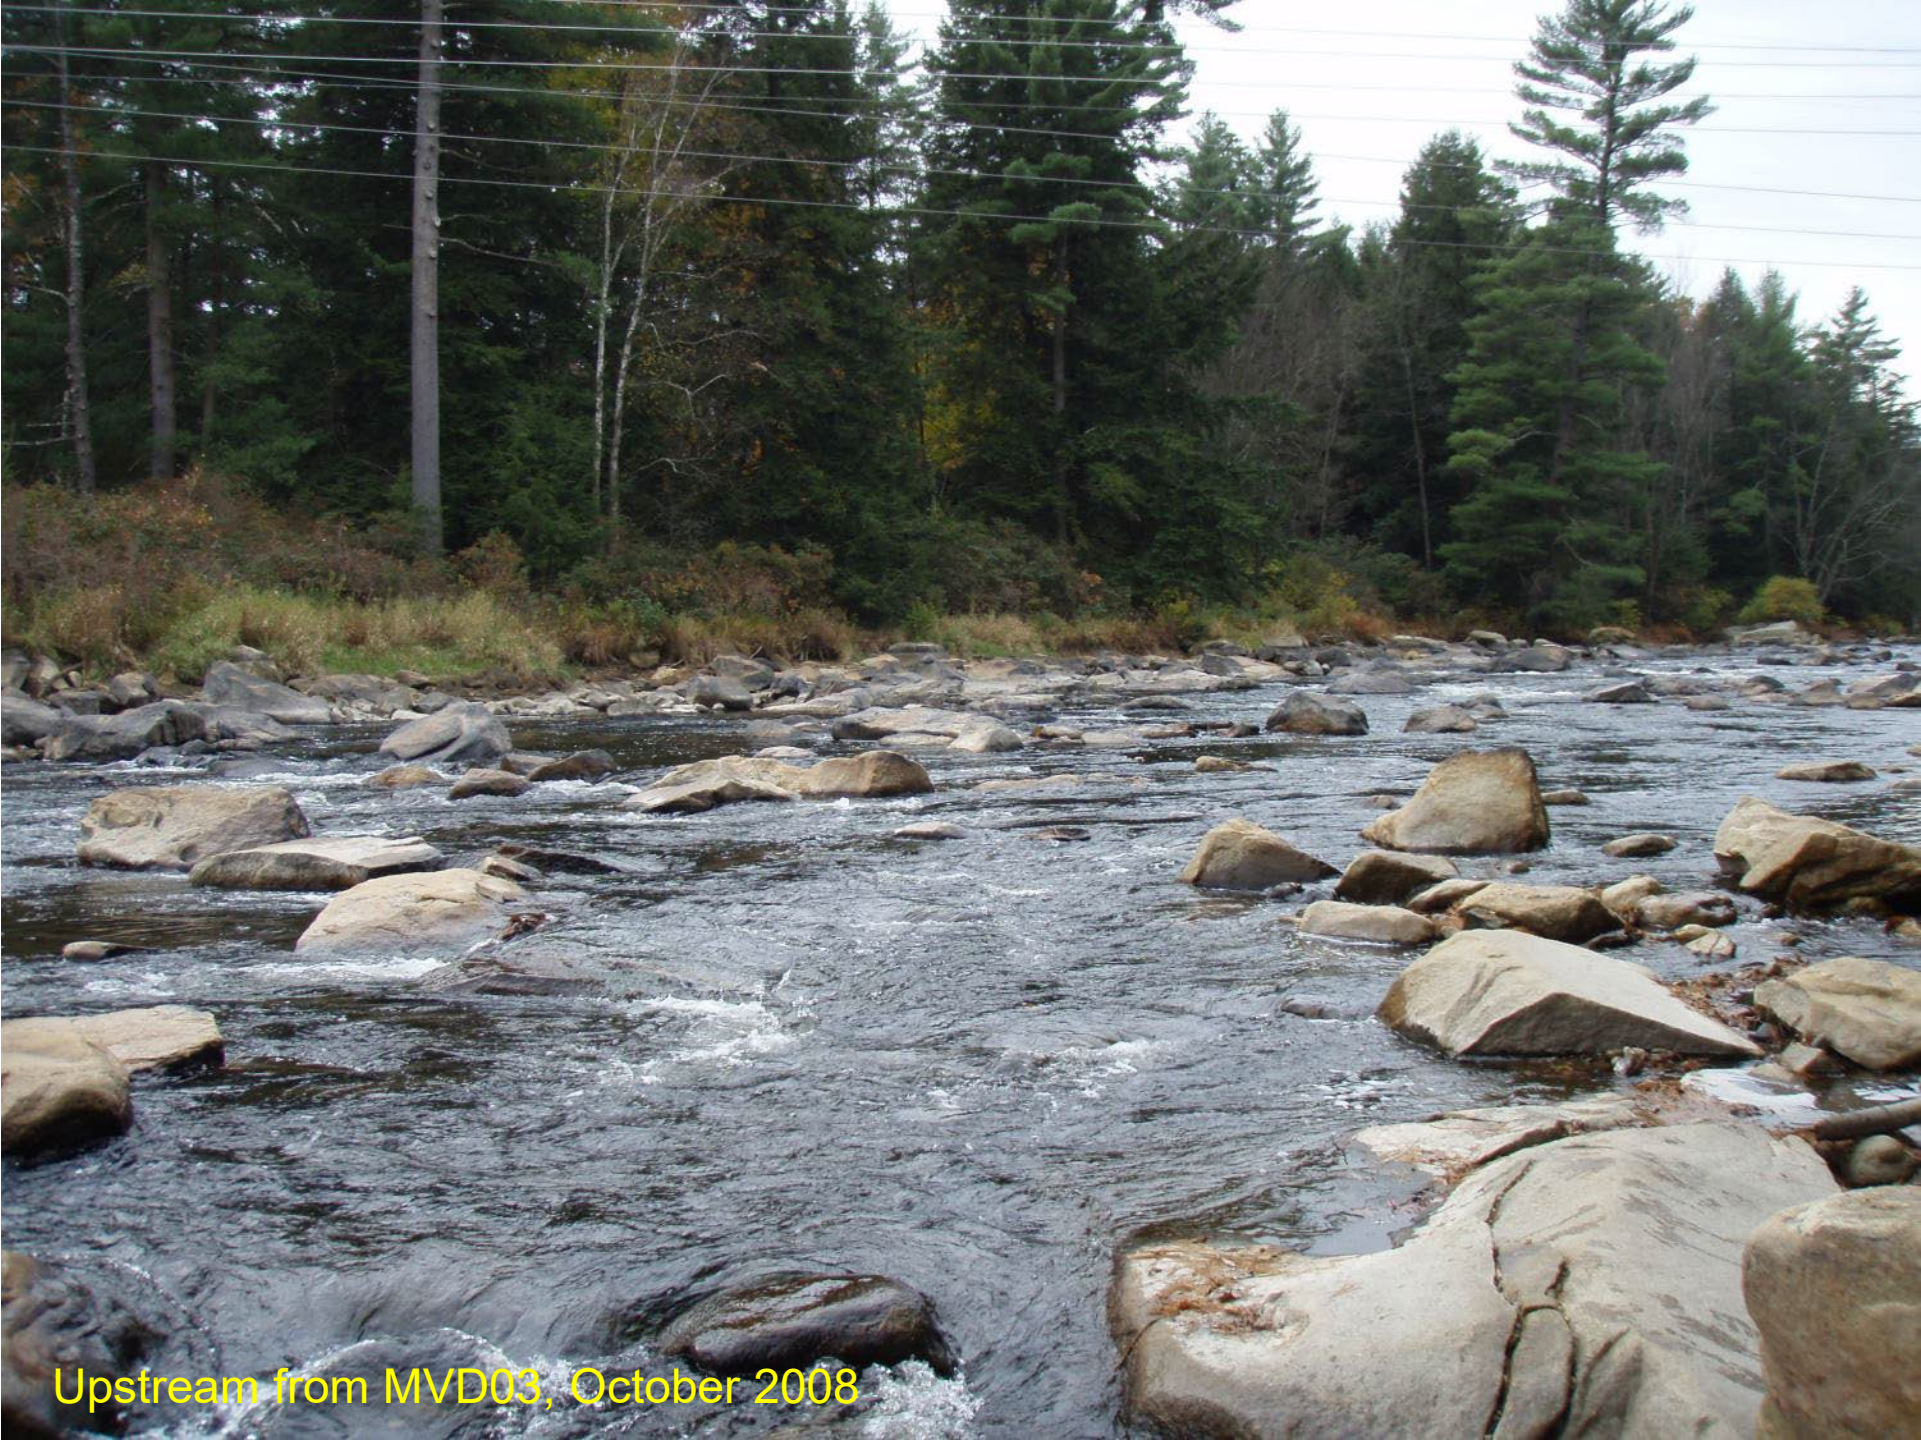
Upstream from MVD03, October 2008

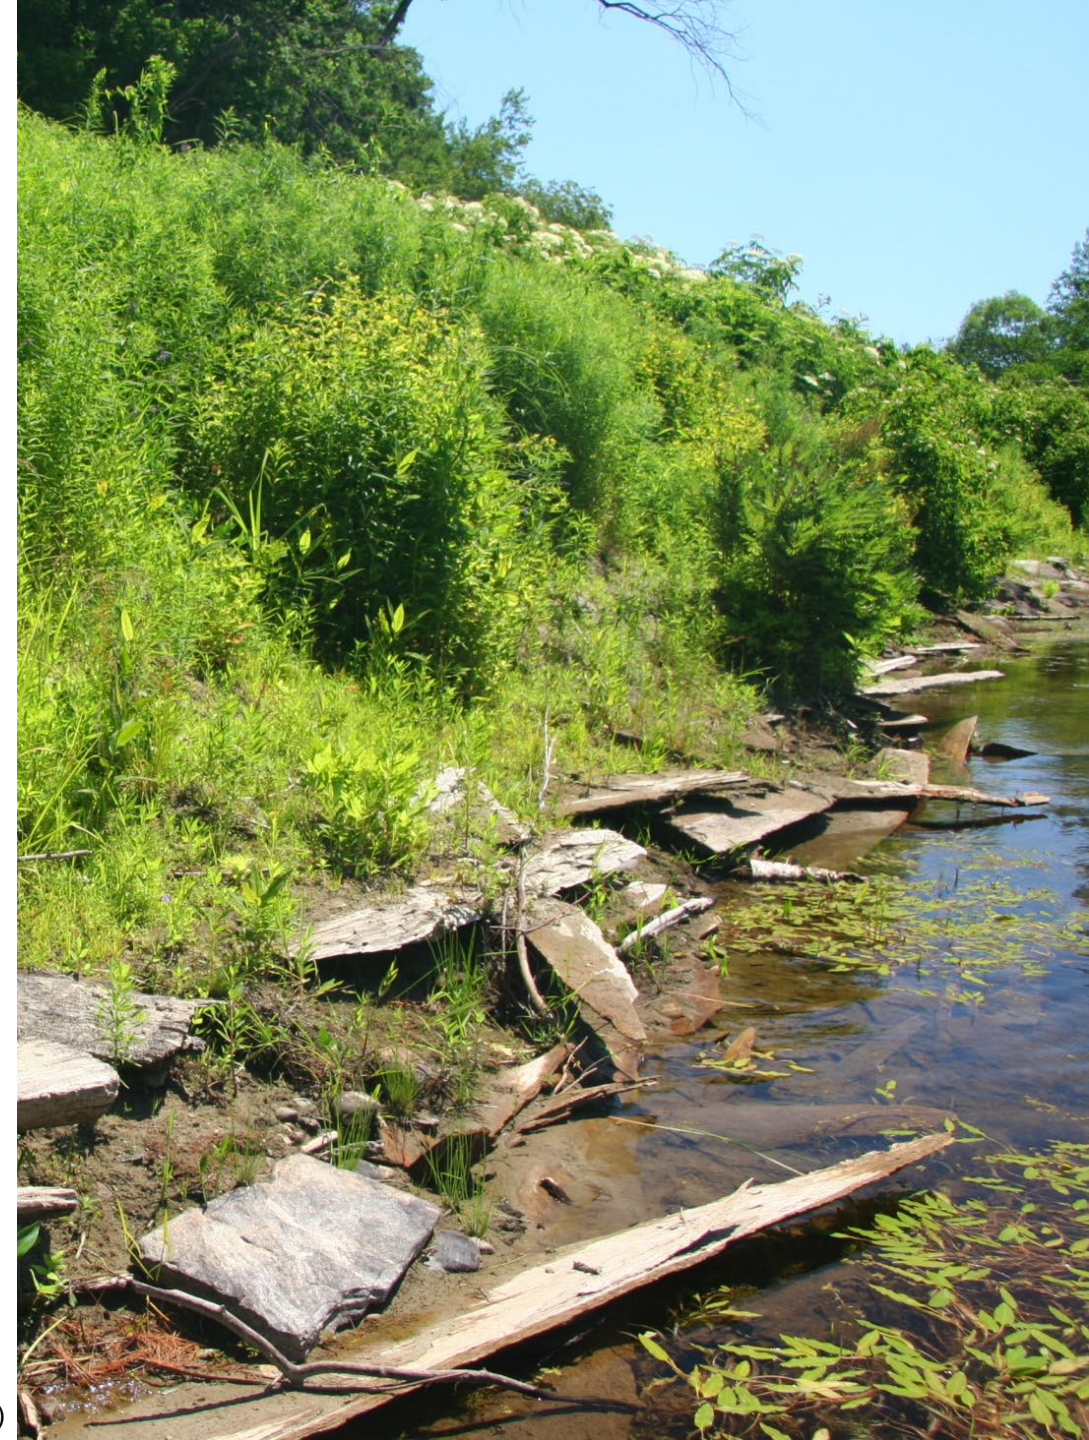
Cut logs eroding out of the left bank, upstream of Head Tide Dam, Sheepscot River, Maine (July 2016)
